## Concrete Coalition Phase II: Concrete Building Performance Record

North elevation of the Van Nuys Holiday Inn prior to damage from the Northridge Earthquake (Clark, 1994).

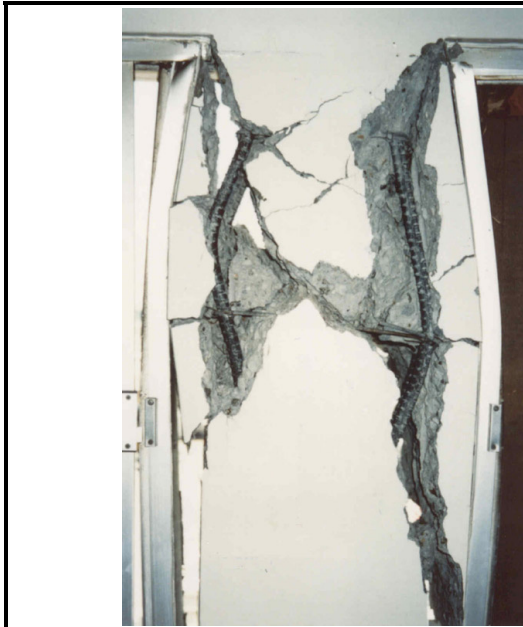
Close-up of x-cracking in column where tie failed. (Comartin et al., 2004)

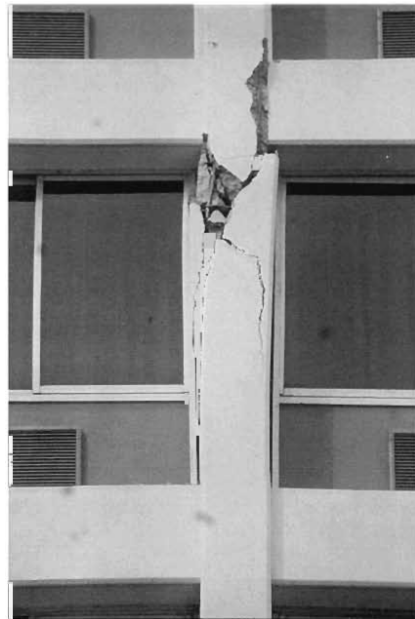
Close-up of x-cracking in column. (EEFIT, 1994)

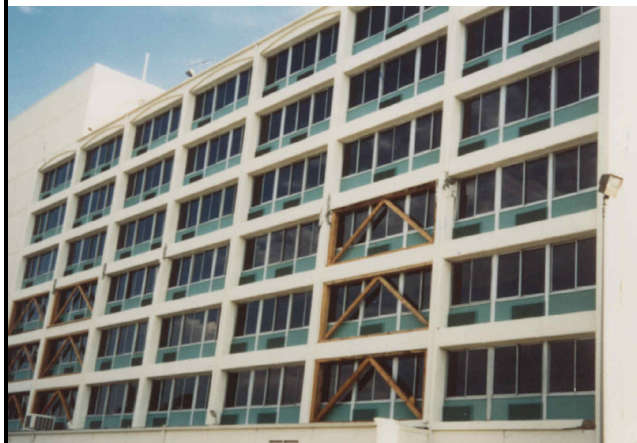
North elevation of the damaged building with temporary shoring in place. (Comartin et al., 2004)

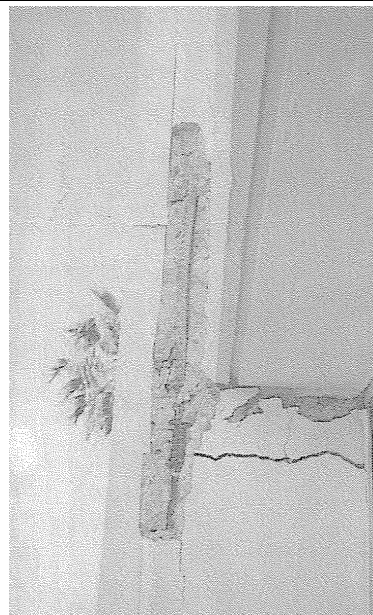
Close-up view of damaged exterior spandrel beam-column connection at fifth floor level. (SSC, 1994)
