Concrete Coalition Phase II: Concrete Building Performance Record

East elevation view of JFK Senior High School Administration Building. (SSC, 1994)

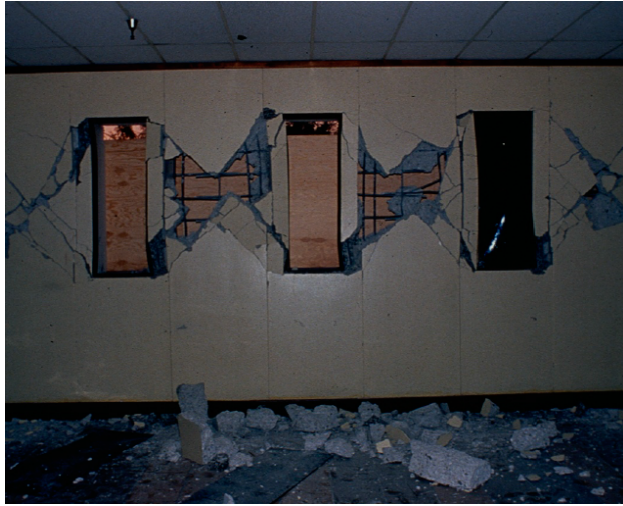
Damaged concrete shear wall at west wall, first floor. (EERI, 1994)

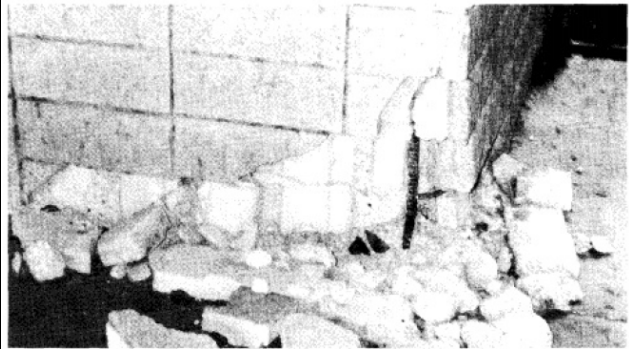
Damaged bottom of masonry shear wall at northeast corner. (SSC, 1994)

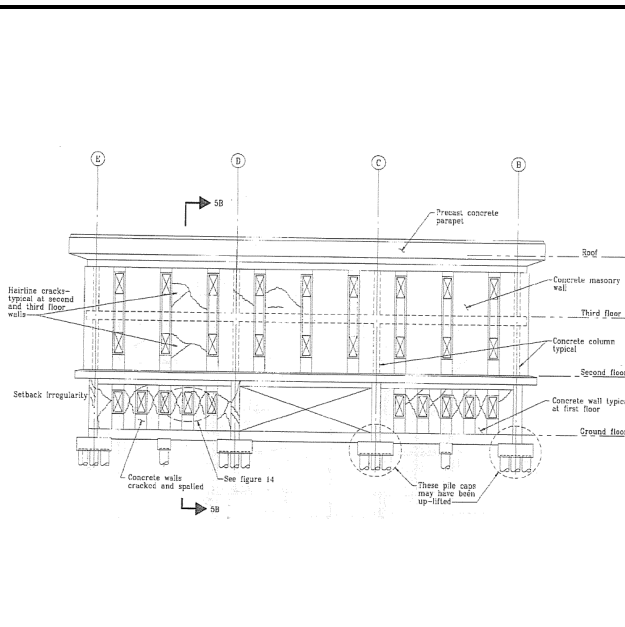
Damage description at west elevation, Line 1 at second floor, line 1A at first floor. (SSC, 1994)

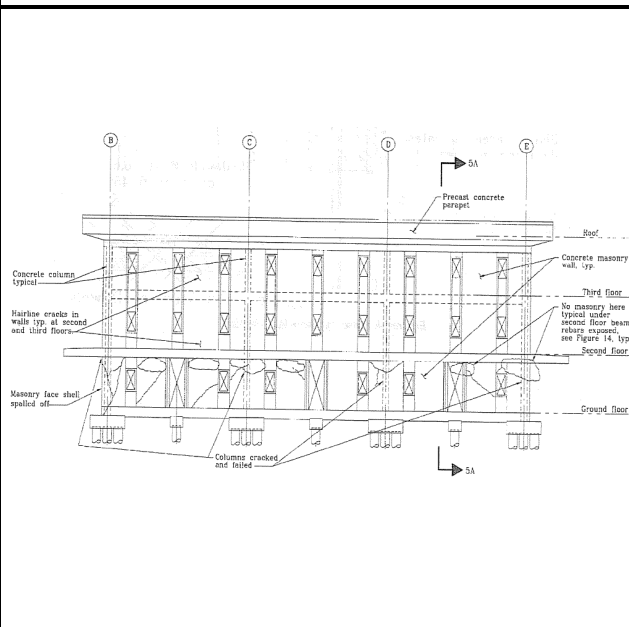
Damage description at east elevation, line 5. (SSC, 1994)
