## Concrete Coalition Phase II: Concrete Building Performance Record

Elevation view of the south wing of St. John's Hospital and Health Center prior to the Northridge Earthquake. (SSC, 1994)

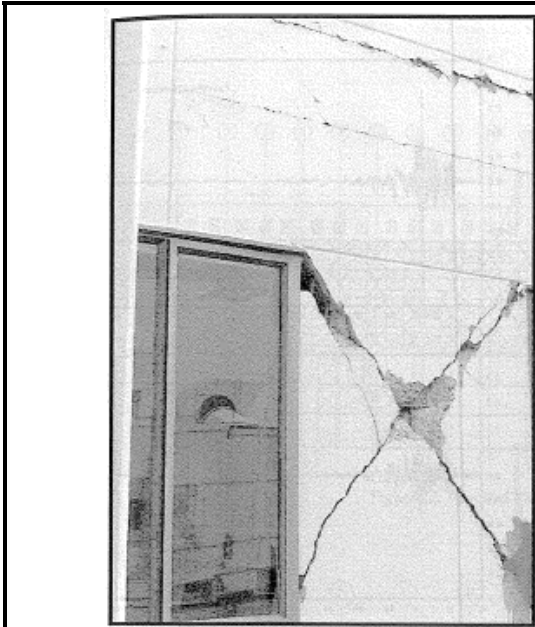
Typical shear wall damage. (SSC, 1994)

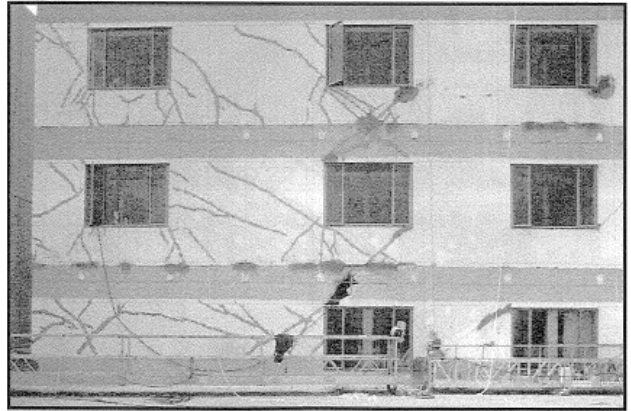
Typical shear wall damage and epoxy injection procedure. (SSC, 1994)
