Concrete Coalition Phase II: Concrete Building Performance Record

Section 1: Basic Building Information

The front of the Stanford Cantor Art Center. (Poland, 2006)

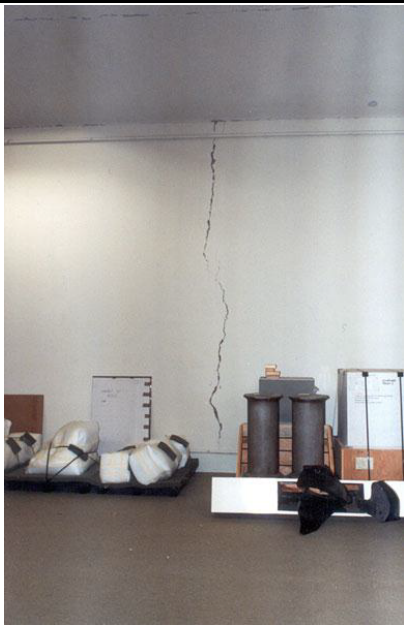
Damage to the interior of the museum.
(Poland, 2006)

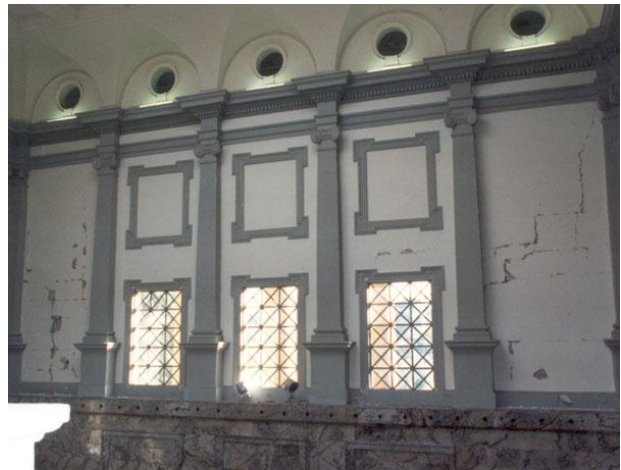
Damage to the interior of the museum.
(Poland, 2006)

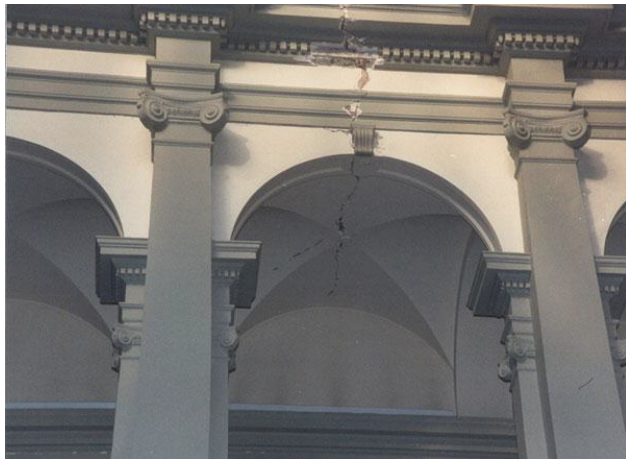
Damage to the ceiling and archway above
the lobby. (Poland, 2006)

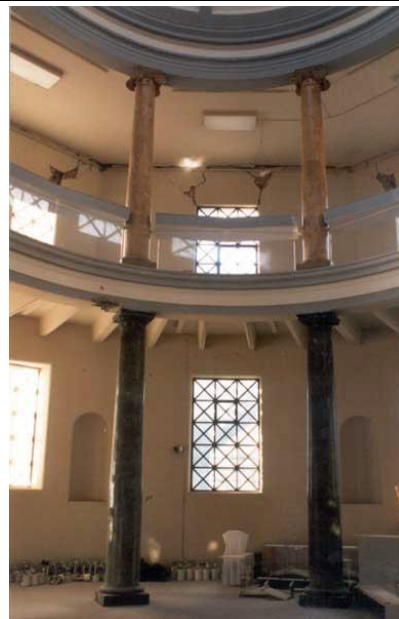
Damage to the interior of one of the
octagonal rotundas. (Poland, 2006)
