Concrete Coalition Phase II: Concrete Building Performance Record

Elevation view of 215 Fremont Street, post retrofit. (Louie International, 2011)

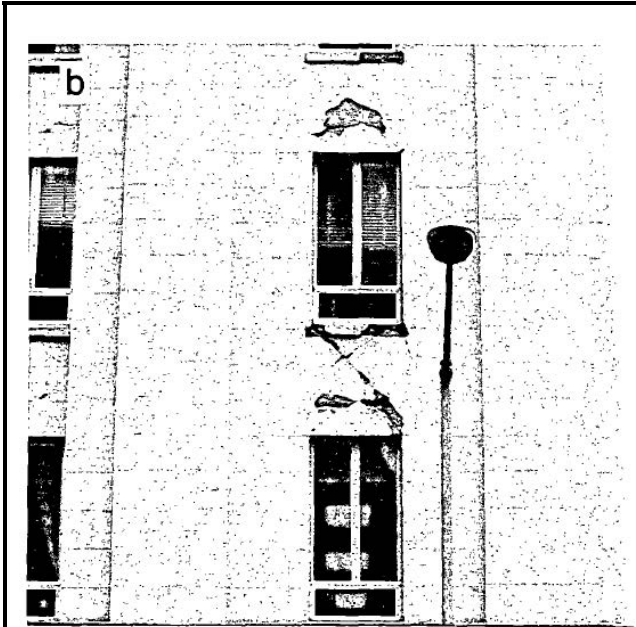
Close-up view of damage to spandrel.
(Lew, 1990)

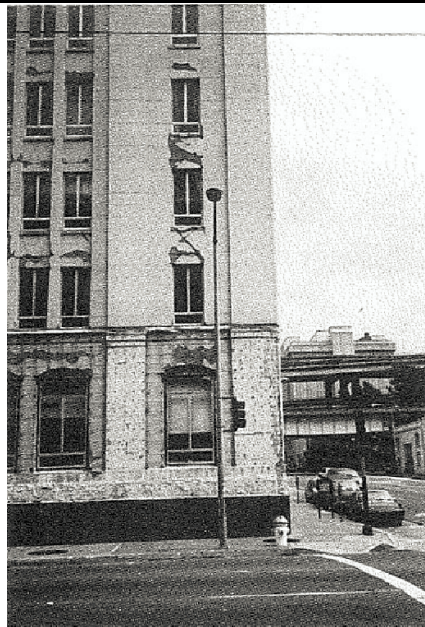
Cracking in exterior spandrels. (Schmid, 1991)
