Concrete Coalition Phase II: Concrete Building Performance Record

Aerial view of the Barrington Medical Building. (Comartin, 1999)

Section 3: Damage Information

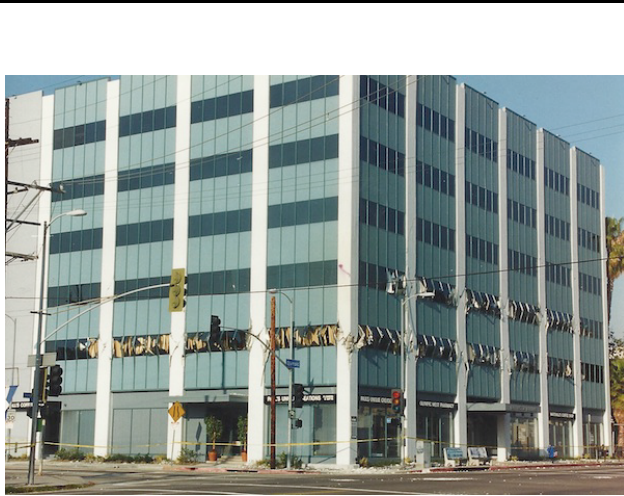
Damage to south and west faces of the building. (Comartin, 1999)

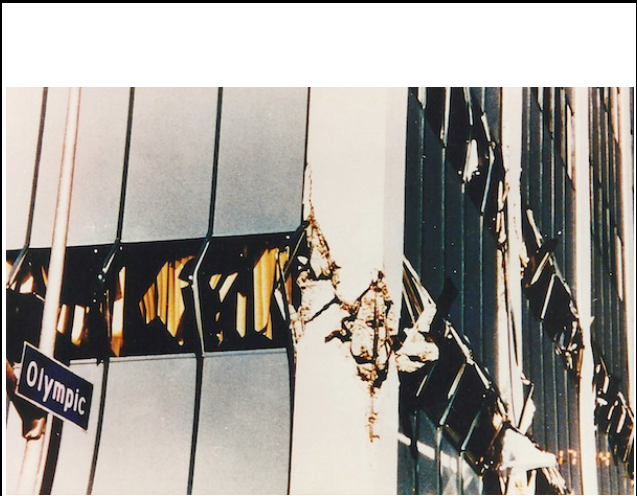
Close-up of damage to southwest column and buckling of adjacent mullions. (Comartin, 1999)

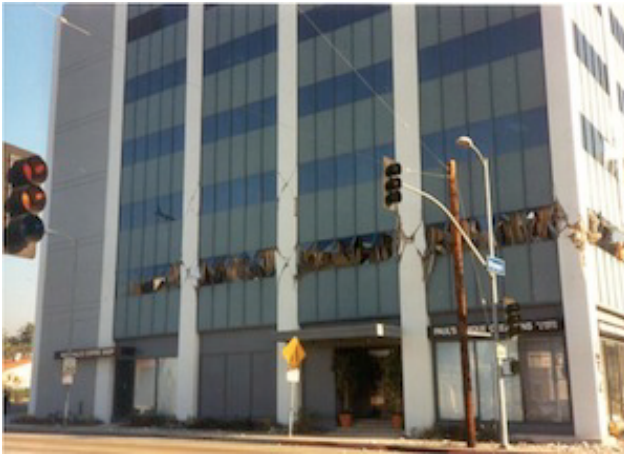
Shear cracking of columns on south face of building. (Comartin, 1999)

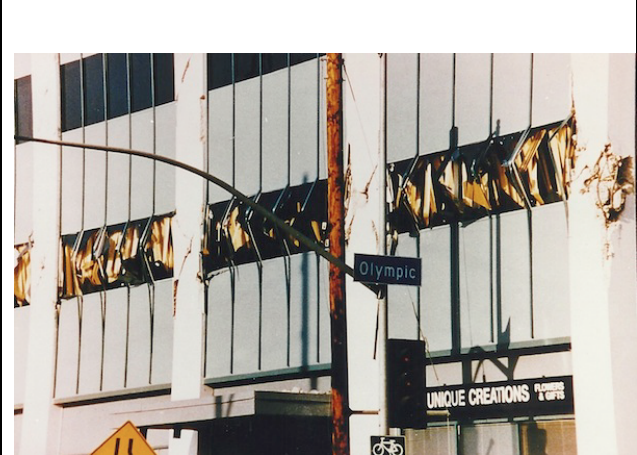
Shear cracking of columns and buckling of mullions on south face of building. (Comartin, 1999)
