**Instructions:** This form is for use in collecting data for phase two of the Concrete Coalition project: Developing a Global Database of Concrete Buildings Damaged in Earthquakes. For more information about how to use this form, see the sample form or view the demo at: <a href="http://concretecoalition.org">http://concretecoalition.org</a>.

#### **Section 1: Basic Building Information**

#### Illustrations of damage:

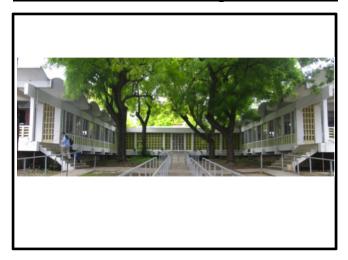
Exterior of school cafeteria. (Federico, 2010)

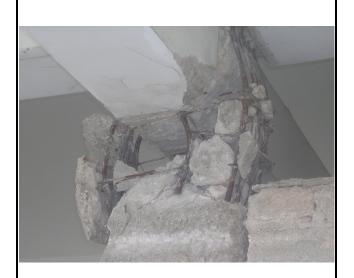
Severe shear failure in column adjacent to partial height URM infill wall. (Federico, 2010)
